NATIONAL TRANSPORTATION SAFETY BOARD

Group Chairman's Factual Report

DCA13MA120

Addendum to Structures Factual Report- Fuel Tanks

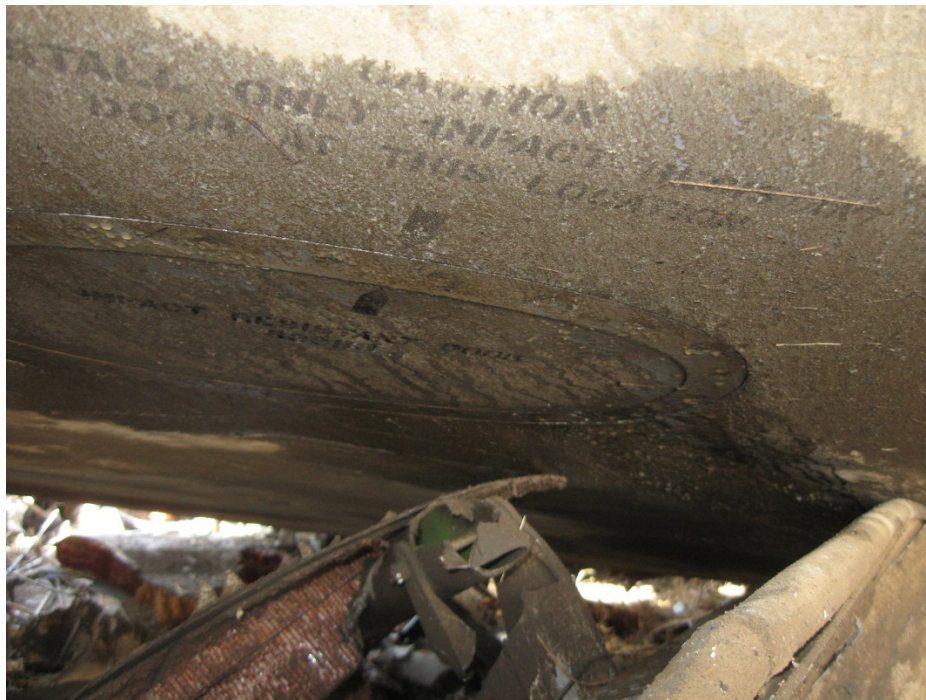
Between Ribs 9 and 10, at approximately Wing Station 425, a running fuel leak was discovered to be emanating from the inboard corner of the interface between the access door and the lower skin. The rate at which fuel was observed to be leaking was not sufficient to cause the fuel to drip onto the ground, but rather run due to surface tension along the wing lower surface to a point where the wing was resting on the ground. Examination of the fuel tank door and skin at the leak location revealed that door had been pushed inward by an externally applied force (there were indications of scraping along the lower wing skin that ran across the door corner). As noted before, the door installation in this location is designed per the requirements of 25.963(e)(1) to withstand the energies associated with a piece of thrown tire tread or low engine debris.

Right Wing Fuel Tank Leak @ WS 425 Tank Access Door

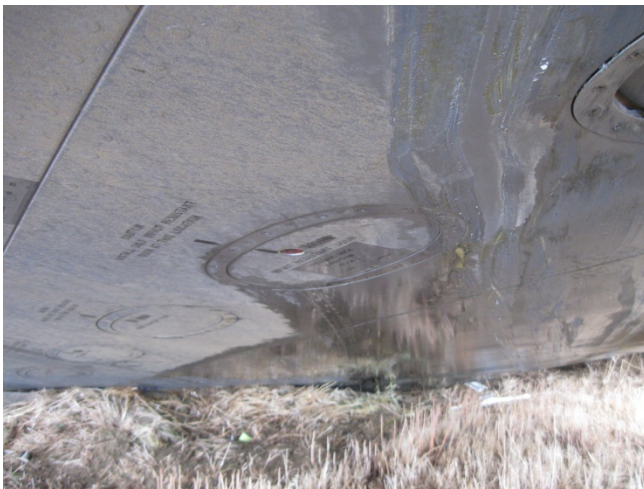
Between Ribs 8 and 9, at approximately Wing Station 400, a running fuel leak was discovered to be emanating from the inboard corner of the interface between the access door and the lower skin. The rate at which fuel was observed to be leaking was not sufficient to cause the fuel to drip onto the ground, but rather run due to surface tension along the wing lower surface to a point where the wing was resting on the ground. Just outboard of the fuel leak location, between Ribs 9 and 10, at approximately Wing Station 425, the fuel tank access door was found with much more damage, with a visible gap between the wing skin and the door. No fuel was observed to be leaking from this location, but it is not known if the fuel tank levels of the airplane and airplane attitude were such that no fuel was spilled or if a fuel leak did occur and sufficient quantities spilled to uncover this location. Examinations of the fuel tank door and skin at the both locations revealed that door had been pushed inward by an externally applied force (there were indications of scraping along the lower wing skin that ran across the doors in both locations). As noted before, the door installations in these location are designed per the requirements of 25.963(e)(1) to withstand the energies associated with a piece of thrown tire tread or low speed engine debris.

Left Wing Tank Leak @ WS 400 Tank Access Door

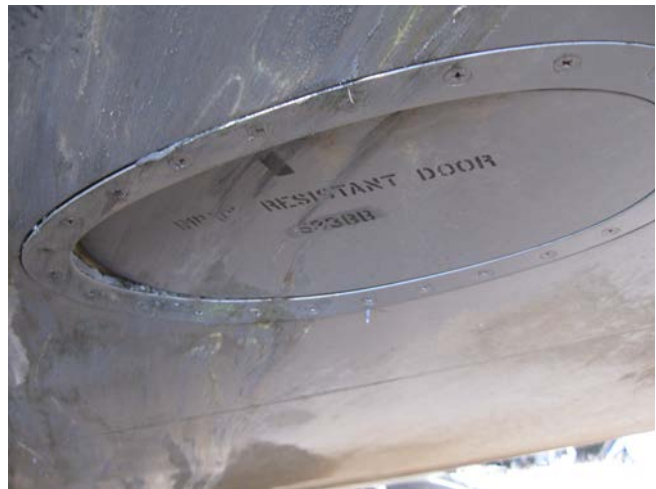
Damage @ WS 425 Tank Access Door

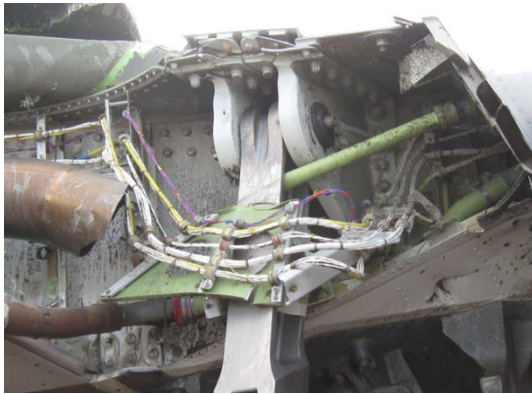
As noted in the main body of the Structures Factual Report, the examination of the left hand wing indicated that there were no signs of structural overload to the wing attachment fittings or the wing box. The R2, R3 and R4 fuse pins were all found failed, with sheared pin sections remaining in the fitting lugs. The R1 overwing exhibited negligible damage, with the strut upper link still attached, indicating failure occurred at the engine end of the upper strut. The R7 & R8 side load link attachment fittings exhibited negligible damage, with the side load links still attached. At all locations, the wing fuel tank boundary was found to be undisturbed and structurally intact.

L/H Wing- R1 Fitting w/ Intact Upper Strut

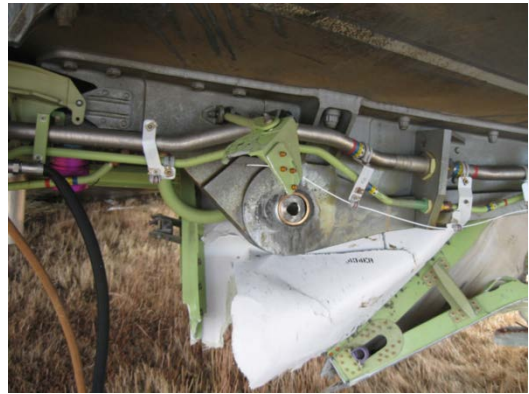
L/H Wing- R2 Fitting w/ Fused Pin

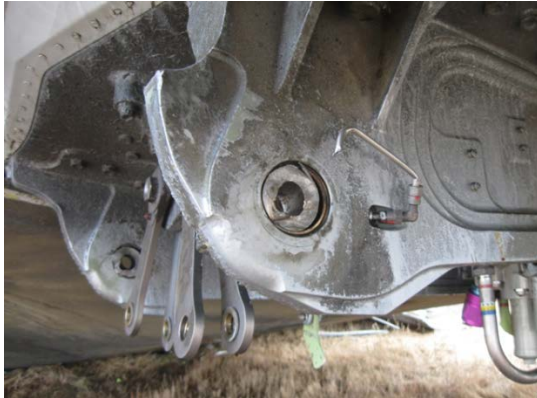
L/H Wing- R3&R4 Fittings w/ Fused Pins

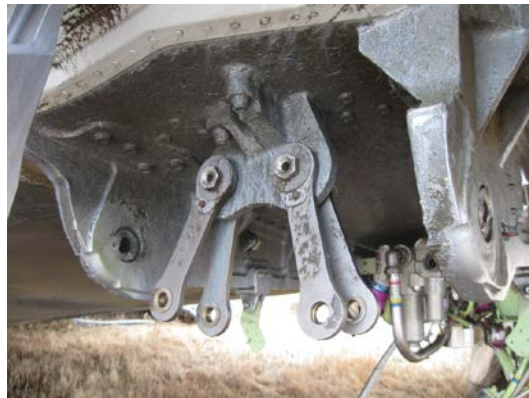
L/H Wing- R7/R8 Attachment

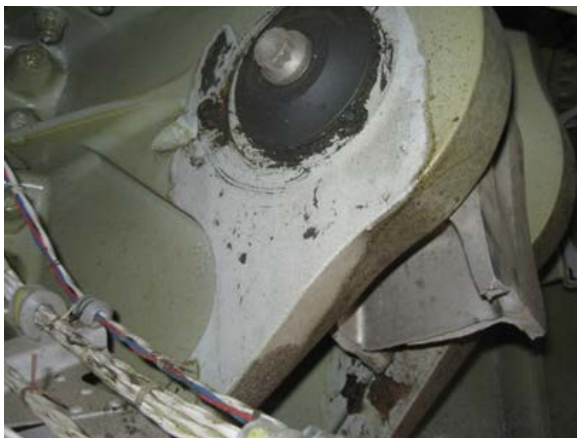
As noted in the main body of the Structures Factual Report, the examination of the right hand wing indicated that there were no signs of structural overload to the R1, R2, R4 and R7/8 attachment fittings or the wing box. The R2 and R4 fuse pins were found failed, with sheared pin sections remaining in the fitting lugs. The R1 overwing exhibited negligible damage, with a portion of the strut upper link still attached, indicating failure in the strut general cross-section. The R7 & R8 side load link attachment fittings exhibited negligible damage, with the inboard side load links still attached. The R4 fitting was found with a fractured lug, but there was no observable damage to the connection between the fitting and the lower wing skin. This damage was consistent with the R3 fitting failure occurring after all other connections were fused, resulting in large lateral loads acting on the R3 fitting lug, during the airplane ground slide. At all locations, the wing fuel tank boundary was found to be undisturbed and structurally intact.

R/H Wing- R1 Fitting w/ Upper Strut Segment

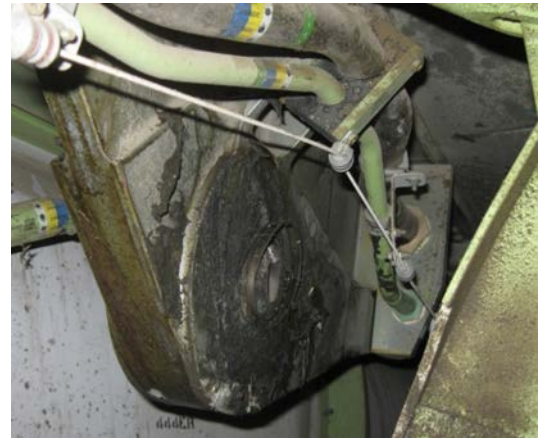
R/H Wing- R2 Fitting w/ Fused Pin

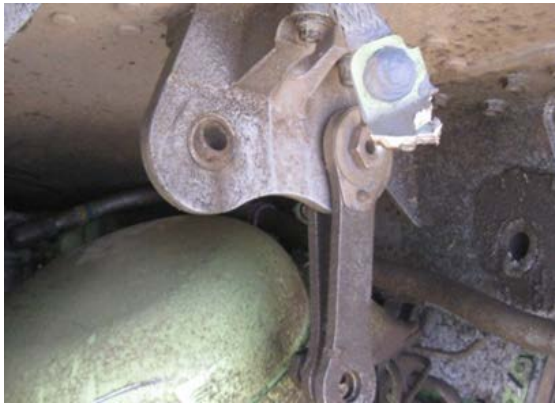
R/H Wing- R7/8 Attachment

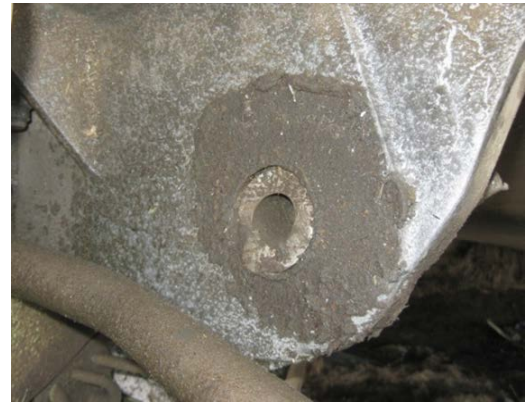
R/H Wing- R4 Fitting w/ Fused Pin

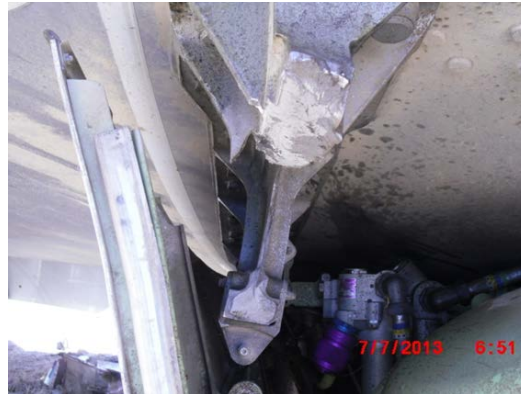
R/H Wing- R3 Fitting w/ Failed Lug

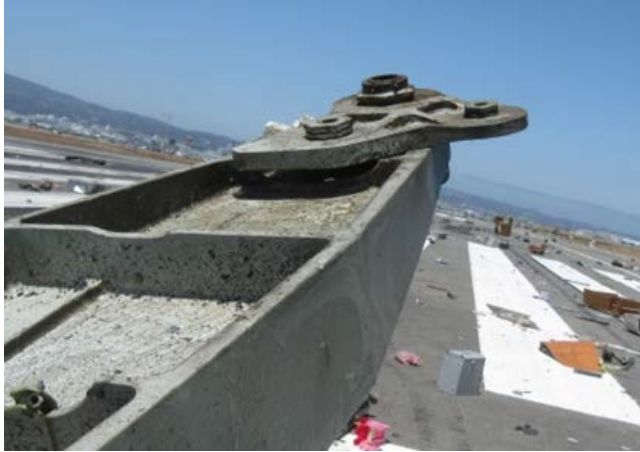
The main landing gear attached to the wing fuel tank at four locations; the drag brace support fitting, the forward trunnion support fitting, the gear retract actuator fitting and the outboard gear beam support fitting. At each of these locations, the damage was limited to the fuse pins (at the drag brace support, the drag strut fused before the pin failed, but the support fitting and rear spar were protected) and the wing fuel tank boundaries were found undamaged and structurally intact.

Outbd End of L/H MLG Beam w/ Failed Fuse
Fuse Pins (R/H similar)

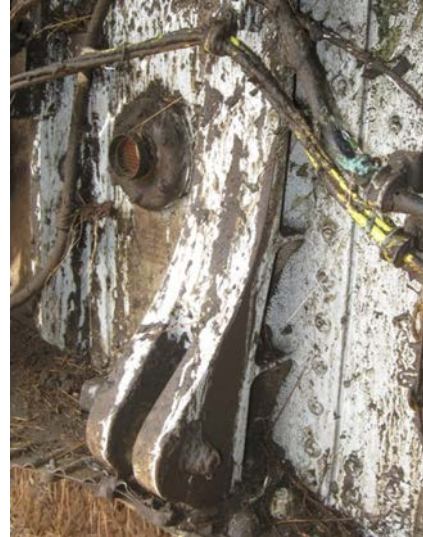
L/H Gear Retract Actuator Ftg w/ Failed
Fuse Pin (R/H similar)

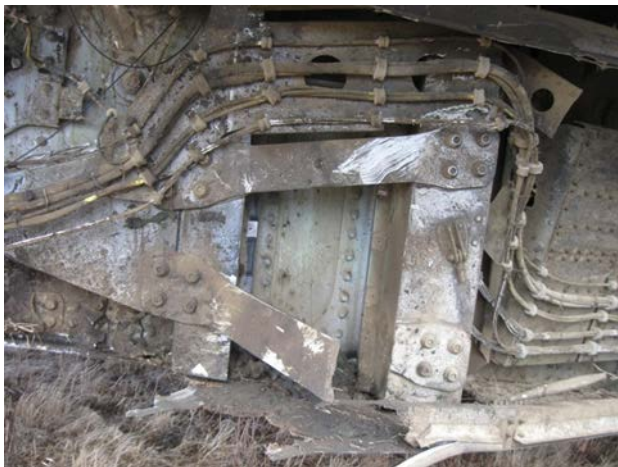
L/H Forward Trunnion Attachment Failure w/ Fused
Lower Housing and Intact Upper Strap (R/H similar)

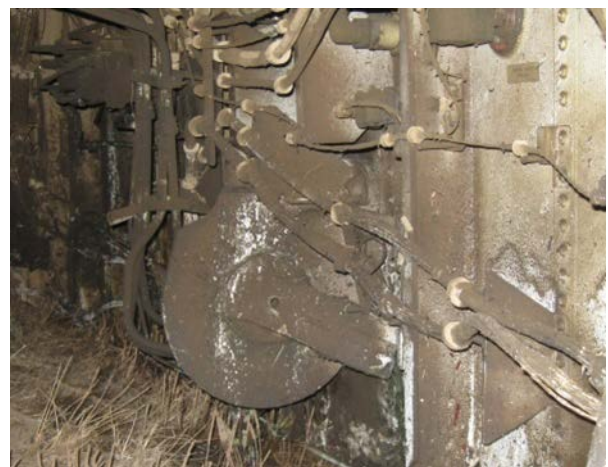
Lower Strap R/H Drag Brace Fitting
w/ Spindle Still on Aircraft (L/H similar)
